RESTORATION OF A FORESTED WETLAND, STONE MOUNTAIN CREEK, DEKALB COUNTY, GEORGIA

James F. Renner

REFERENCE: *Proceedings of the 1991 Georgia Water Resources Conference*, held March 19 and 20, 1991, at The University of Georgia. Kathryn J. Hatcher, Editor, Institute of Natural Resources, The University of Georgia, Athens, Georgia, 1991.

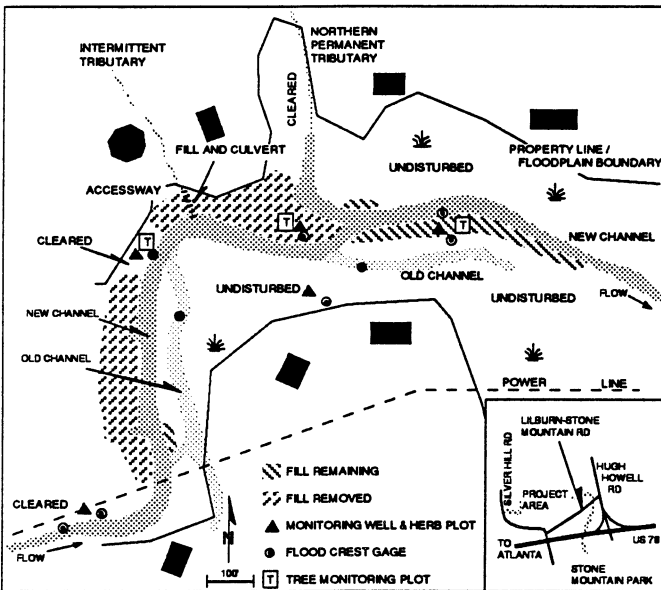
In April, 1990, implementation of the restoration plan began. Fill was removed from 1.1 acres on the northern and western banks of the creek (Figure 1). Excavation ceased as soon as the buried root mat was observed, because it was believed that the benefit of natural resprout would outweigh any adverse impact of incomplete fill removal. Where fill was removed, streambanks were graded to at least a 3:1 slope. The streambank along one section of undredged channel (power line right-of-way) also was graded in order to minimize erosion and allow increased floodwater conveyance. Difficulty arose when the adjacent landowner threatened to refuse further access. As a compromise, EPA approved spoil disposal in an intermittent tributary ravine. A culvert was installed, and the ravine was filled to a depth of about 5' with the remaining spoil. The banks were rip-rapped where the culvert emptied into the main creek channel. In areas where fill was allowed to remain, no grading or grubbing was implemented.

Figure 1. Stone Mountain Creek wetland restoration site. All disturbed areas were planted with trees except power line.
