STREAM CHANNEL POST-RESTORATION MONITORING OF THE SOQUE RIVER, GEORGIA

REFERENCE: *Proceedings of the 2001 Georgia Water Resources Conference*, held March 26-27, 2001, at the University of Georgia. Kathryn J. Hatcher, editor, Institute of Ecology, The University of Georgia, Athens, Georgia.

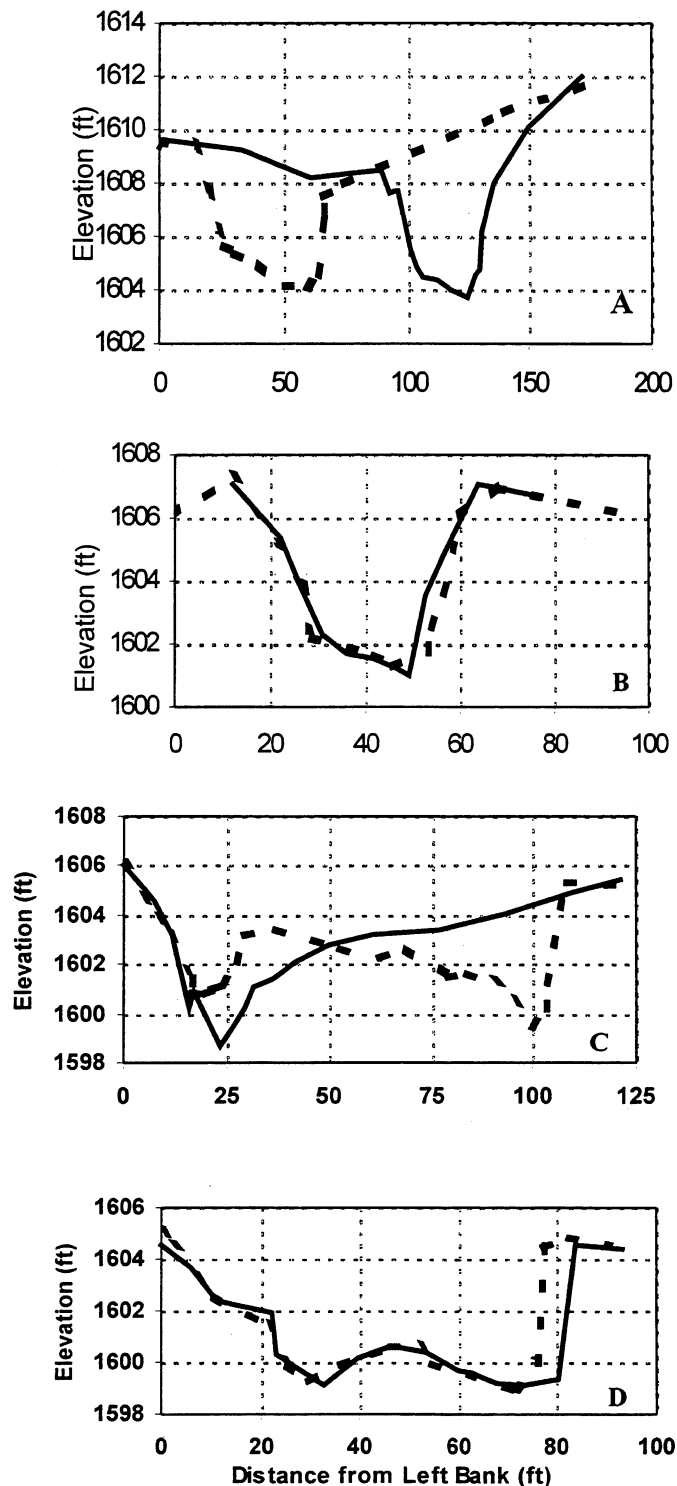
Four channel cross-sections (XS) were surveyed pre-(April to June 1998) and post-restoration (December 2000) to aid in the restoration design and to monitor the success of the project, respectively (Figure 1, A-D). Station LFS10 (location 1+94) was located at the reconstructed meander as graphically depicted in Figure 1A. LFS50 (7+09) was located along an unrestored, but stable, section of the existing channel. LFS60 (9+60) was located across a multi-channel reach that exhibited extreme bank failure on the right bank as depicted in Figure 1C. LFS70 (12+39) was located immediately downstream of the restoration project, and consequently was in a segment considered unaffected by the restoration. Thus, station LFS 70 was representative of pre-restoration conditions of the stream. Bankfull (return interval 1-2 years) measurements included average depth (D_{bkf}), width (W_{bkf}), and cross-sectional area (A_{bkf}). In addition, bankfull width to depth ratios (W/D) were calculated.

D_{bkf} increased at stations LFS10, LFS50 and LFS 60. However, the most dramatic increase in D_{bkf} was observed within one of the reconstructed channels at LFS60, where it more than doubled (0.8 to 1.8 ft). W_{bkf} decreased at all XS with the exception of LFS70 where it increased from 47 to 54 feet. The loss of approximately four feet of bank material from the right bank contributed to the increase in W_{bkf} at LFS70 (Figure 1D). A_{bkf} increased at all XS with the exception of LFS50. W/D ratios decreased at stations LFS10, LFS50 and LFS60 and increased at LFS70. However, the largest changes were observed within the reconstructed channels at LFS10 (where W/D decreased from 29 to 21) and LFS60 (50 to 17). W/D increased slightly at LFS 70, immediately downstream of the restored reach, from 65 to 69.

Figure 1. Left Fork Soque River Cross-Sections (Broken Line = Pre-Construction, April-June 1998, Solid Line = Post-Construction, Dec. 2000; A = LFS10, B = LFS50, C = LFS60, D = LFS70; Vertical Axis Exaggerated)

It was anticipated that the restored section of the constructed channel would maintain low width-depth ratios and bed material sizes would increase. Conversely, in the unrestored sections downstream, the opposite result was expected. Two years after restoration, low W/D ratios (17 to 21) were maintained as designed and constructed.
