UPGRADING THE NRCS Y-14 DAM IN GWINNETT COUNTY

Gregg W. Hudock, P.E.^{1/}, Richard W. Humphries, P.E.^{2/}, Sam Fleming, P.E.^{3/} & Terry West, P.E.^{4/}

REFERENCE: *Proceedings of the 2005 Georgia Water Resources Conference*, held April 25-27, 2005 at The University of Georgia. Kathryn J. Hatch, editor, Institute of Ecology, The University of Georgia, Athens, Georgia.

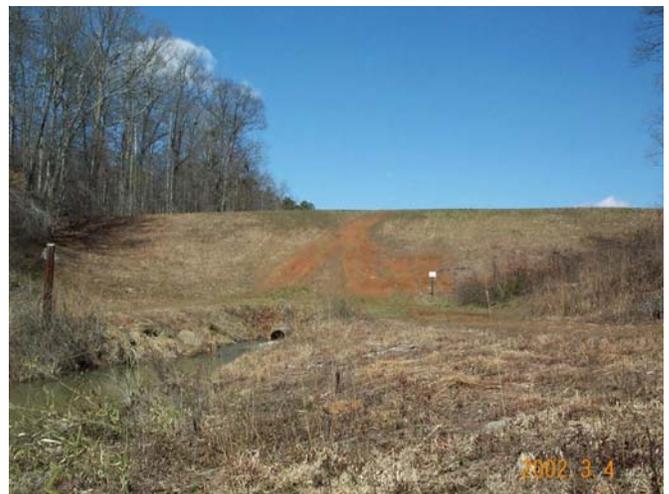
Figure 1. Existing Y-14 dam prior to rehabilitation.

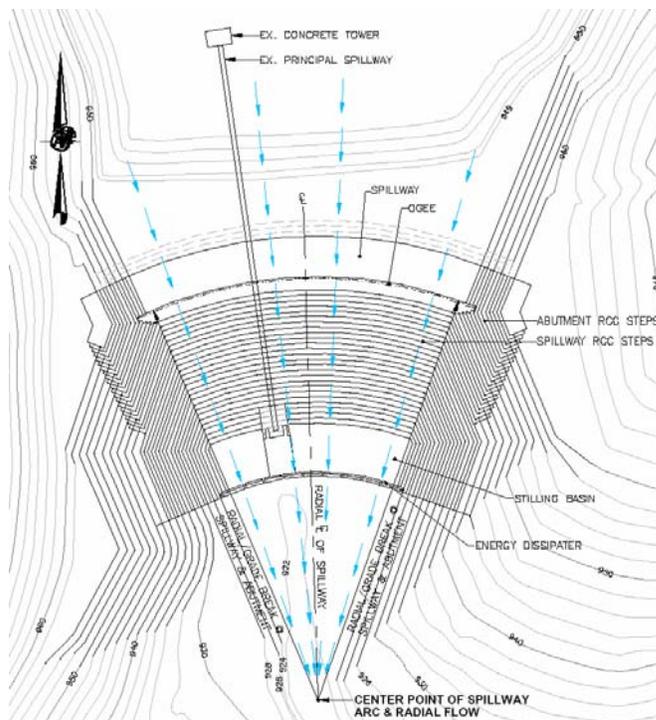
The selected design has an arch shaped spillway crest and chute. The crest is 180 feet wide and the chute is formed by one foot high steps. The energy at the base of the spillway is dissipated in a hydraulic jump which is contained within a RCC lined stilling basin. The arch shape was selected to maximize the length of the overflow crest and to gradually converge the flow down the chute so that the stilling basin can be constructed within the river valley at the downstream toe of the dam. The principal spillway riser and pipe effectively remain

Figure 2. Plan view of the proposed Y-14 structure.

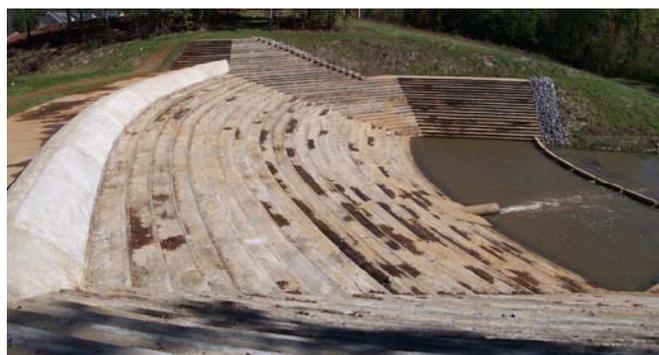
Figure 4. Completed Y-14 arced RCC spillway and ogee weir.

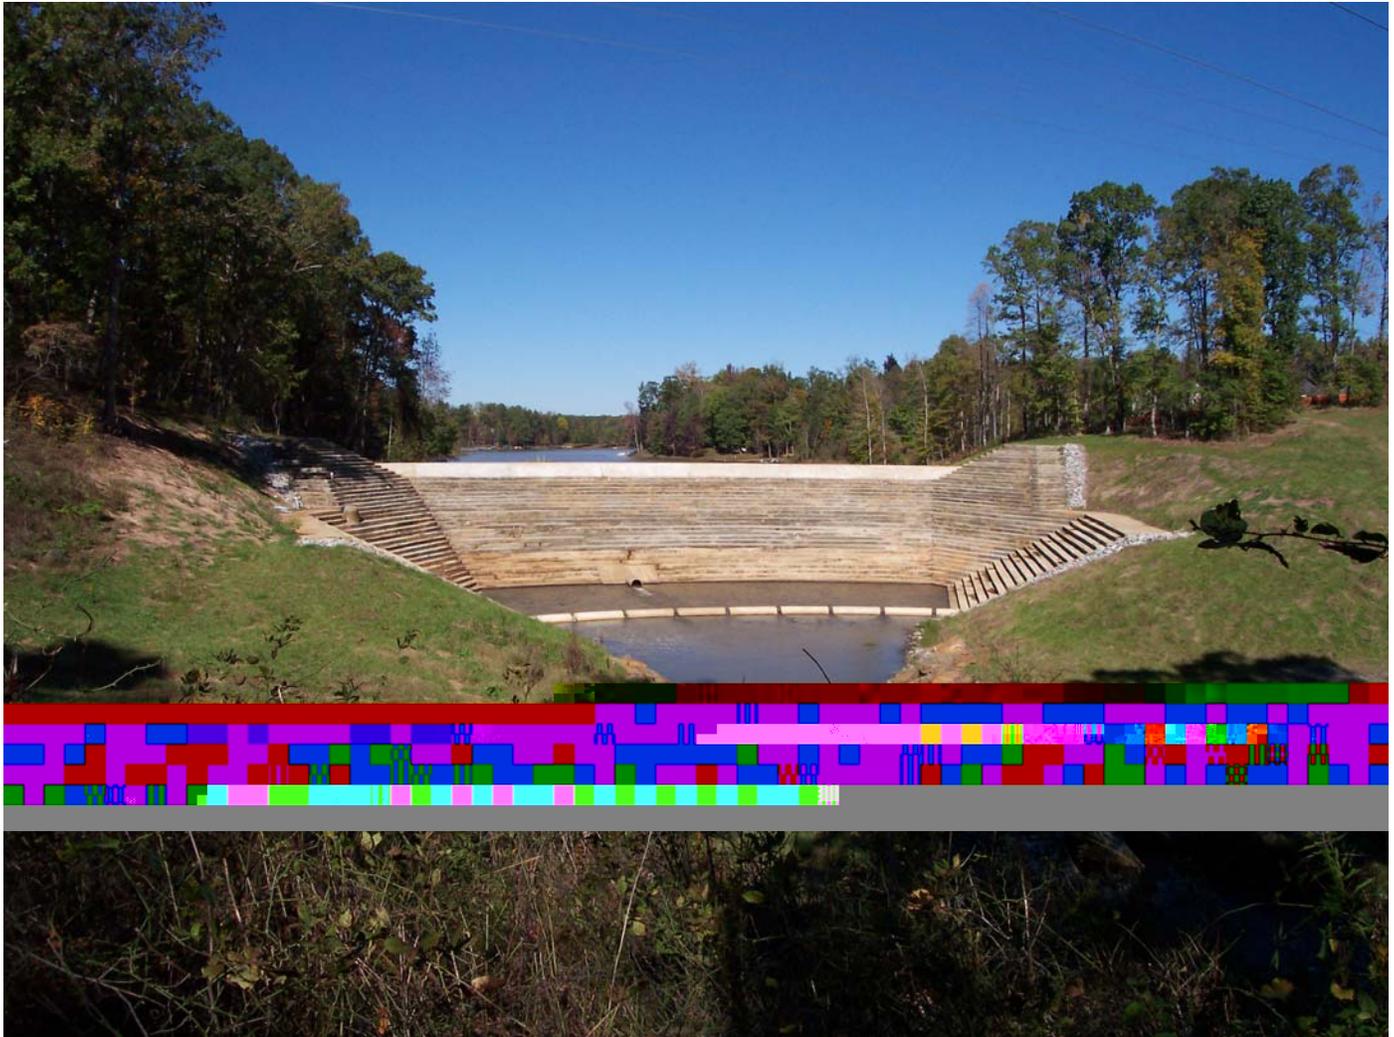
Figure 5. Y-14 RCC Spillway one year after completion.
