# A CLOSER LOOK AT SOUTHEAST REGIONAL DRINKING WATER WELLS: IDENTIFYING PROBLEMS USING A DOWN WELL CAMERA

REFERENCE: *Proceedings of the 2005 Georgia Water Resources Conference*, held April 25-27, 2005, at the University of Georgia. Kathryn J. Hatcher, editor, Institute of Ecology, The University of Georgia, Athens, Georgia

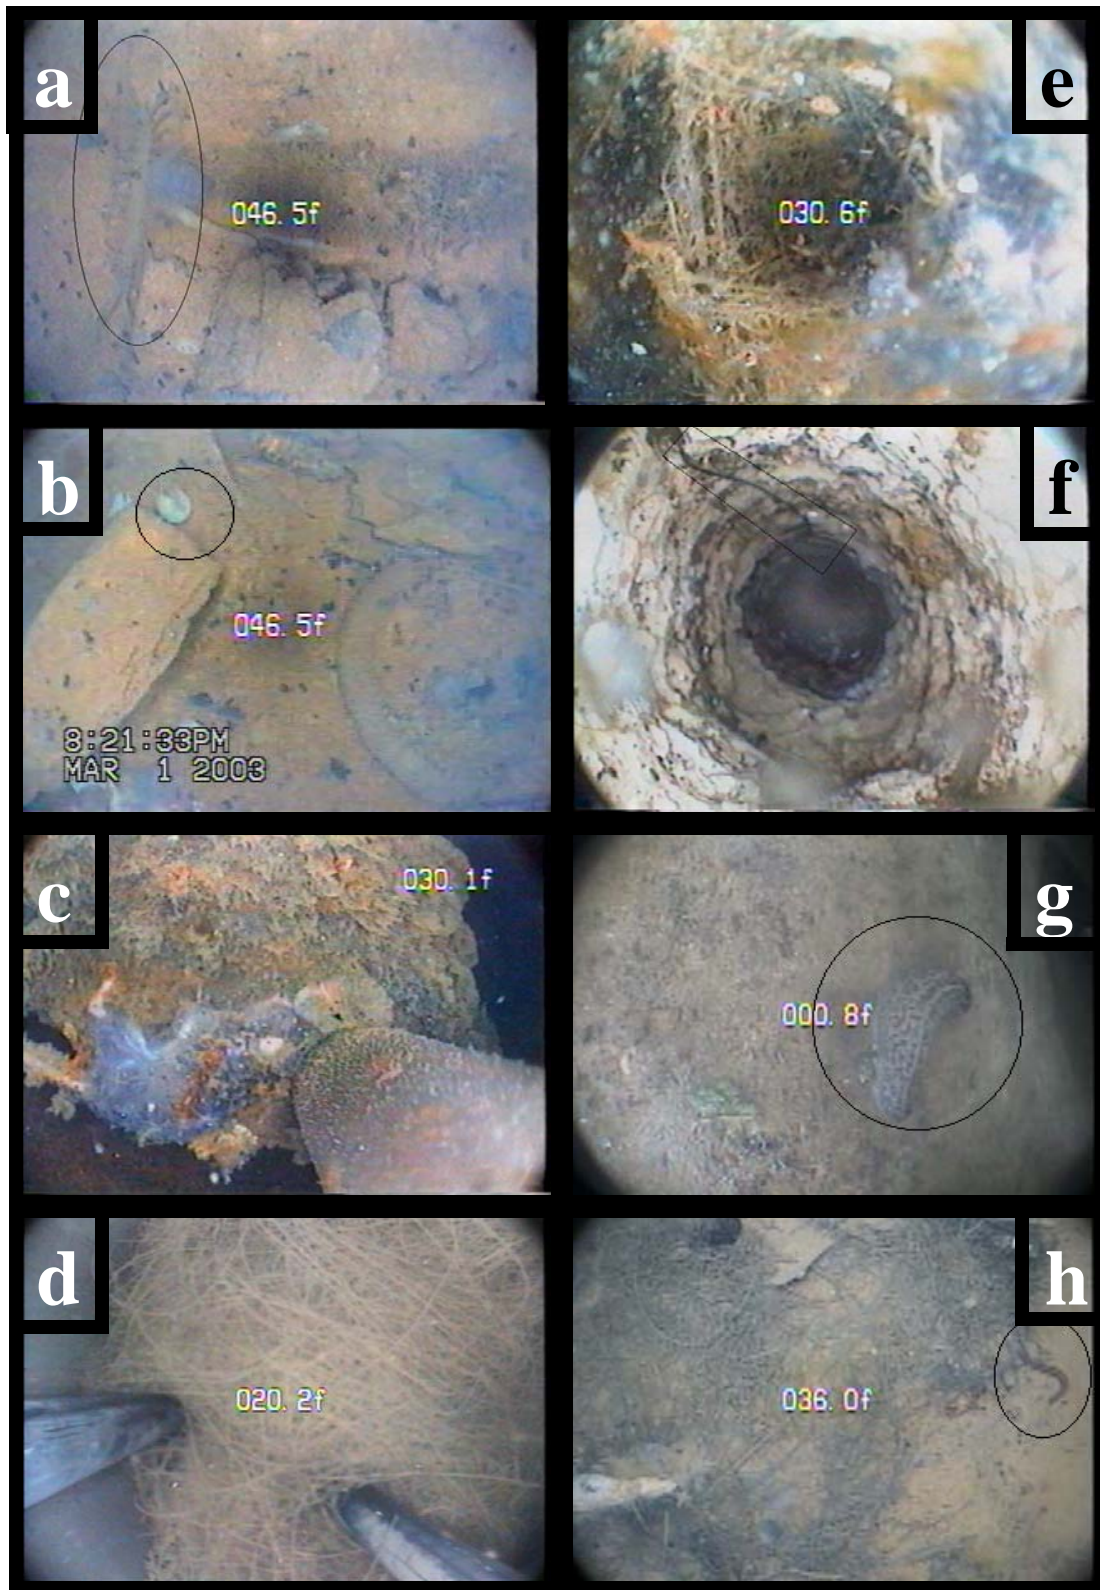
The still frames captured from the video footage have been sorted into three general categories, organisms, leaks, and foreign material. Photographs of organisms (arthropod, insect, annelid, mollusk, plant part, and bacteria/fungi colony) are shown in Figure 3, consisting of: 3a) centipede, 3b) grub, 3c) microbial colony on pump intake, 3d) peach tree roots, 3e) plant roots, 3f) root growing down old steel casing into a deep confined aquifer (Floridan), 3g) slug, 3h) earthworm living in a mat of plant roots.

**Figure 3. Organisms observed in wells: a) centipede, b) grub, c) microbial colony on pump intake, d) peach tree roots, e) plant roots, f) root growing down old steel casing into a deep confined aquifer (Floridan), g) slug, h) earthworm living in a mat of plant roots.**

Video inspection of well bores effectively explained the presence of pollution in groundwater in cases where simple wellhead inspection would not. Plant and animal organisms indicated that the shallow groundwater in many bored wells is under direct influence from surface-water (Figures 3a, 3b, 3c, 3d, 3e, 3g, and 3h). In Figure 3f, a plant root was seen growing into a deep confined Floridan aquifer. This well was over 50 years old and the steel casing was leaking and almost completely corroded (Figure 4e). Wells or groundwater that harbor these organisms cannot be expected to be free of coliform bacteria. This study was unable to determine if these organisms were indigenous in these aquifers or present only because these wells had introduced surface-water.

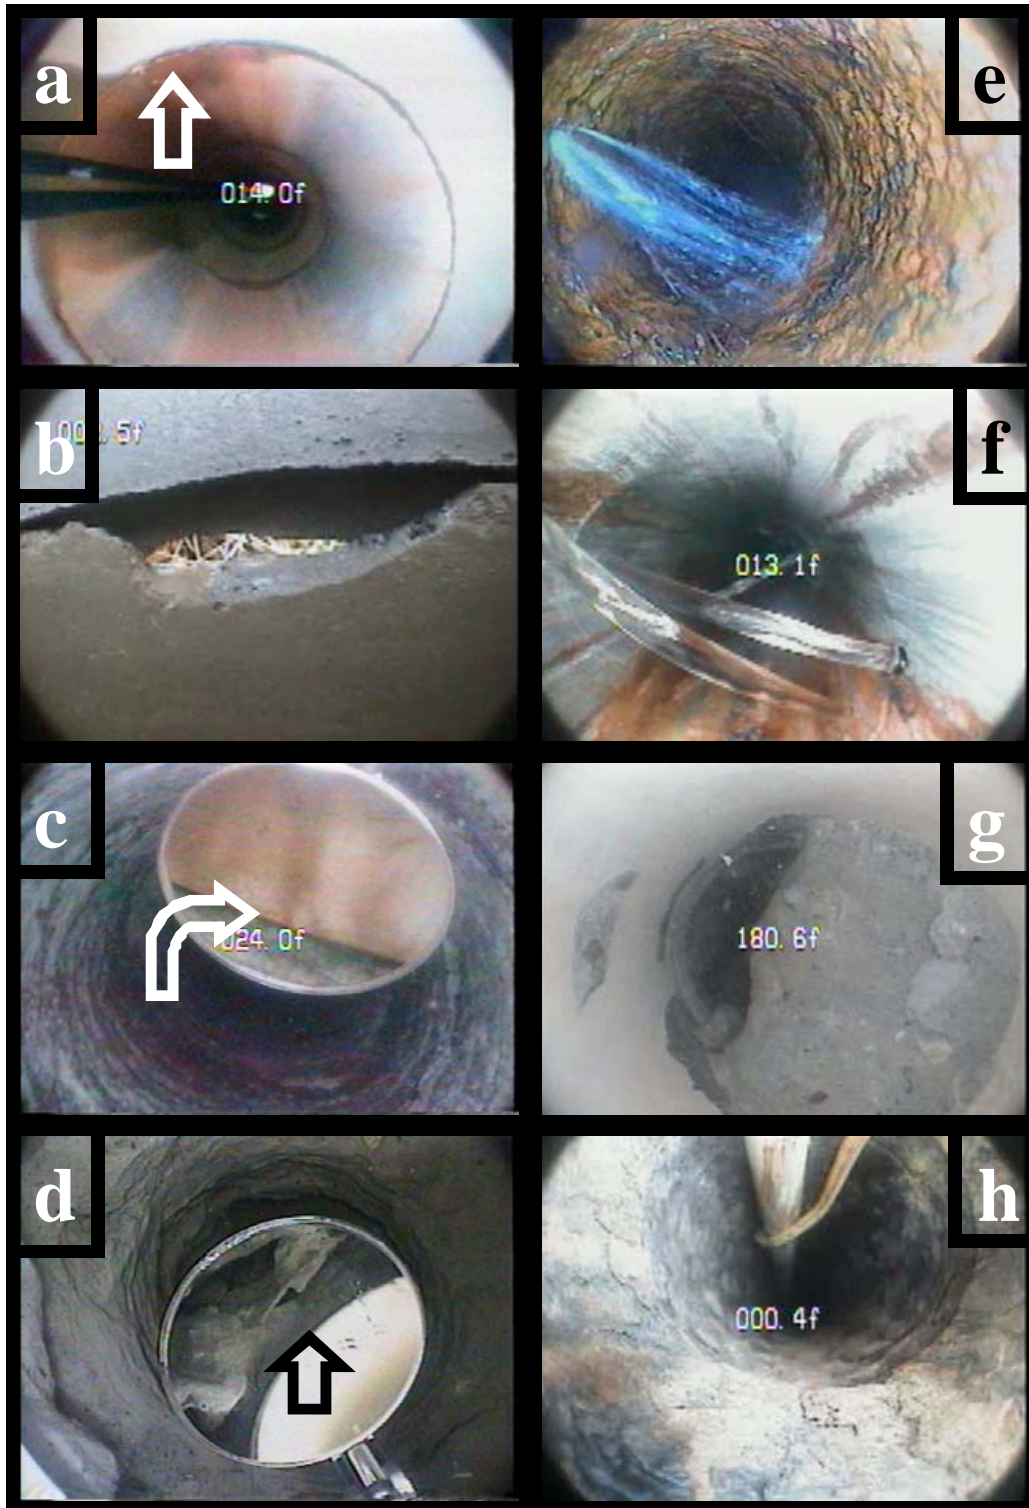
Figure 4. Leaks, seepage, and holes observed in wells: a) iron staining due to shallow seepage through a casing joint, b) hole in the casing at ground level, c) mirror image of a leak at the junction of the casing with bedrock, d) mirror image of a leak at the junction of the casing with the confining unit, e) hole through old steel at the alluvial aquifer zone in a confined aquifer well, f) holes in galvanized steel in the alluvial aquifer zone in a confined aquifer well, g) encrustation caused by a leak at a casing joint, h) severely corroded steel.

Figure 4 contains the pictures of leaks, holes, and seepage that are specifically described as: 4a) iron staining due to shallow seepage through a casing joint, 4b) hole in the casing at ground level, 4c) leak at the junction of the casing with bedrock, 4d) leak at the junction of the casing with the confining unit, 4e) hole through old steel at the alluvial aquifer zone in a confined aquifer well, 4f) holes in galvanized steel in the alluvial aquifer zone in a confined aquifer well, 4g) encrustation caused by a leak at a casing joint, 4h) severely corroded steel. Foreign materials seen in wells are revealed in Figure 5 and consist of: 5a) plastic disposable lighter, 5b) nylon dog chew bone, 5c) ball, 5d) leaves, 5e) nail, 5f) hair dryer, 5g) pie pan, 5h) electrical wire.

Identifying inadequacies in well construction such as leaks, holes, and shallow seepage explained the pathways for both bacterial and chemical contaminants (Figures 4a,

Deterioration of construction materials was identified in Figures 4e, 4f, 4g, and 4h, which were corrosion of steel casing in all instances. The inability to achieve a watertight seal of casing with rock or the confining unit was observed in two wells (Figures 4c and 4d, a crystalline rock and a confined aquifer well, respectively). Grouting the lower portion of the entire length of casing would have prevented this.

4b, 4c, 4d, 4e, 4f, and 4g). In most cases grouting would have prevented or appreciably reduced these problems.

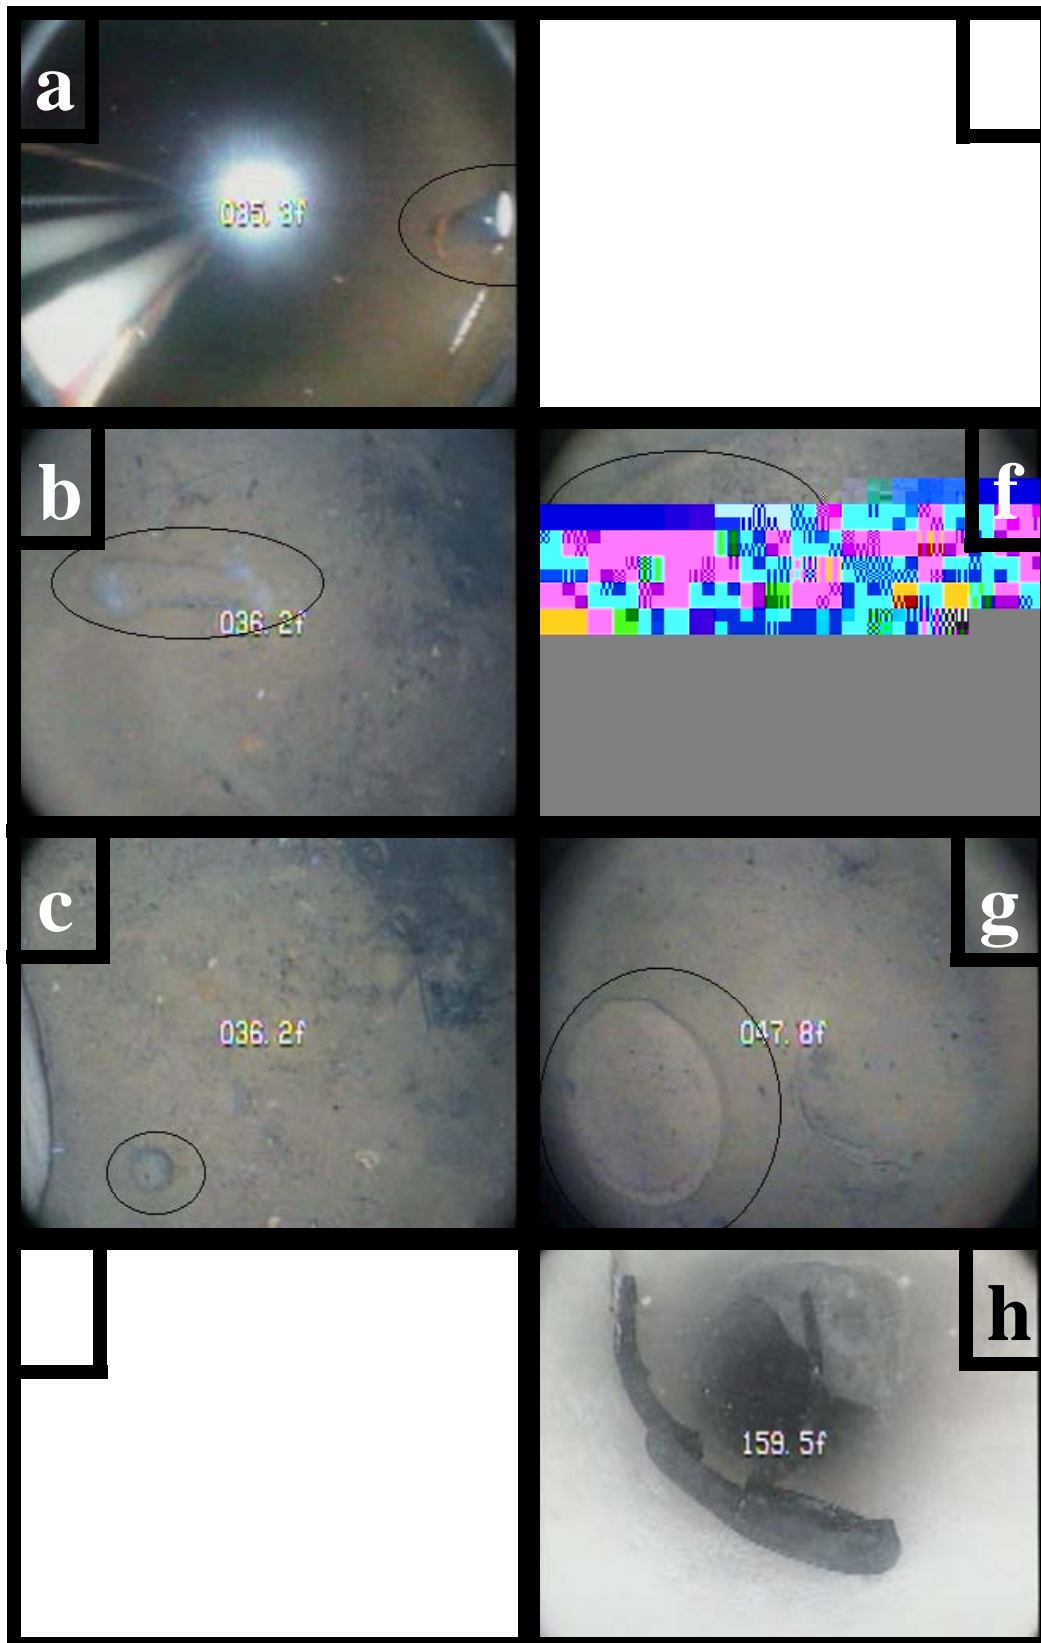
Figure 5. Foreign material observed in wells: a) plastic disposable lighter, b) nylon dog chew bone, c) ball, d) leaves, e) nail, f) hair dryer, g) pie pan, h) electrical wire.

Over the years wells can accumulate foreign material that may not cause problems as seen in Figures 5a, 5b, 5c, 5d, 5e, 5f, 5g, and 5h. However, this serves as a warning or indicator that if it will fit, it can enter a drinking water well.
