RESTORATION OF THE WORMSLOE PLANTATION SALT MARSH IN SAVANNAH, GEORGIA

REFERENCE: *Proceedings of the 2005 Georgia Water Resources Conference*, held April 25-27, 2005, at the University of Georgia. Kathryn J. Hatcher, editor, Institute of Ecology, The University of Georgia, Athens, Georgia.

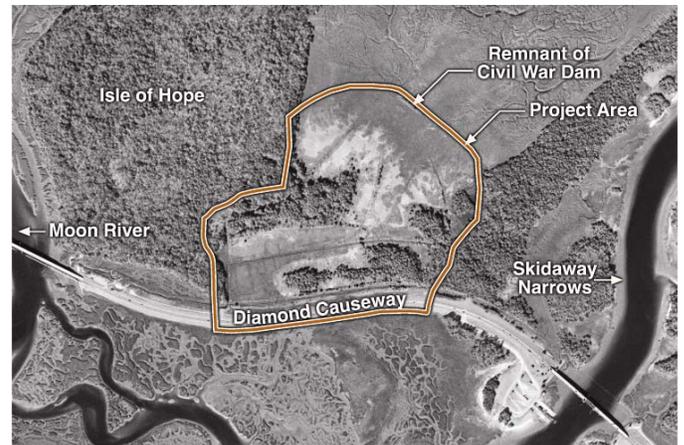
Figure 3. 2001 Aerial photograph of project site.

to be virtually clear-cut. A 2001 aerial photograph indicates current conditions (Figure 3.)
