CLAYTON COUNTY WATER AUTHORITY'S GATEWAY STREAM RESTORATION PROJECT

REFERENCE: *Proceedings of the 2005 Georgia Water Resources Conference*, held April 25-27, 2005, at the University of Georgia. Kathryn J. Hatcher, editor, Institute Ecology, The University of Georgia, Athens, Georgia.

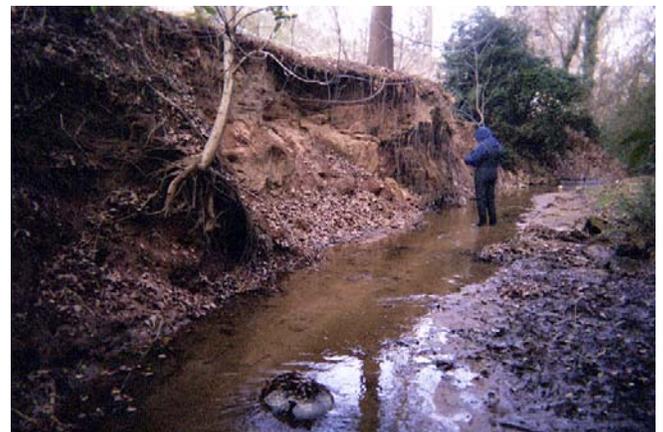
Village. This channelized section of East Jesters Creek was deeply incised, with exposed 8- to 10-foot-high banks (Figure 1). The streambed was relatively wide, ranging from 15 to 20 feet, and the unconsolidated sandy substrates continually shift and are transported to downstream water supply reservoirs. Historically, the stream was dredged and relocated, probably for agricultural purposes. Prior to restoration, the creek was a channelized and straightened (i.e., a Rosgen "F5") stream (Rosgen, 1994).

Figure 1. Typical erosion in Jesters Creek.

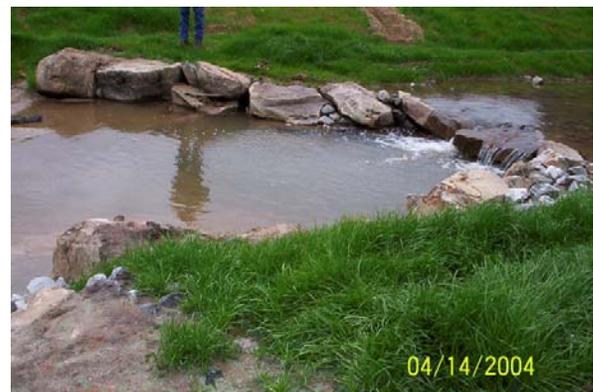
Cross-vanes were used to control the grade, create the step/pool bedform, create instream habitat, and increase sediment transport capacity. The structures were constructed to direct the stream flow over the structure, into the center of the channel, and away from the stream banks, thus reducing shear stress on the banks (Figure 3).

Figure 3. Typical cross-vane structure.
