GEOLOGIC CONTROLS ON EROSION, SEDIMENTATION OF STREAMS, AND POTENTIAL FOR GROUNDWATER CONTAMINATION IN SOUTHWESTERN GEORGIA

Mark D. Cocker

AUTHORS: Advanced Geologist, Georgia Department of Natural Resources, 19 MLK, Jr., Dr., SW, Atlanta, Georgia 30334
REFERENCE: *Proceedings of the 2007 Georgia Water Resources Conference*, held March 27–29, 2007, at the University of Georgia.

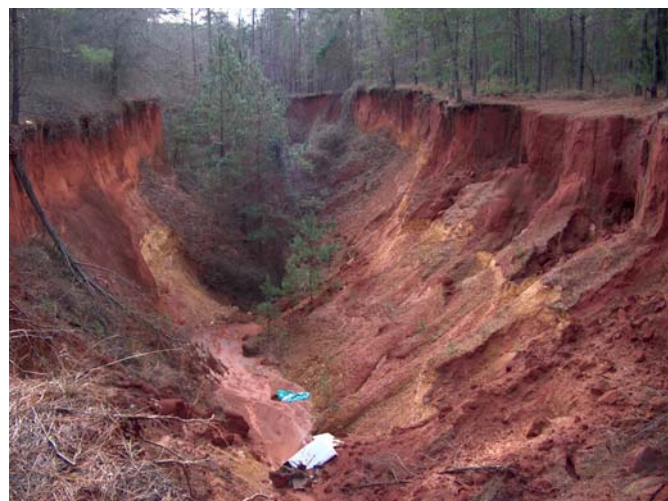
Figure-3 Extreme erosion and downcutting into soft Claiborne Group sandstone (lighter material) after breaching of the more resistant Altamaha sandstone (dark red sandstone on top), a road culvert concentrated storm runoff and caused the development of this canyon. Mass-wasting with down-dropped blocks of the Altamaha Formation occurs due to slope failure. Refrigerator at bottom of canyon for scale.

The Claiborne Group is a shallow marine to near-shore, white, yellow, to reddish brown, locally cross-bedded, fine-grained sand and sandstone. Thin, less than 3 feet thick, clay beds are locally present. This unit weathers rapidly to a fine, white to light brown sand. In much of the map area (Fig. 2), the Claiborne Group is overlain by the more resistant, Miocene Altamaha Formation (Fig. 3) and is protected from erosion. Breaching of the Altamaha

caprock leads to rapid erosion of the underlying Claiborne Group (Fig. 4). A considerable volume of sand (estimated to be about 22,500 cubic yards) has been removed from the gullied area shown in Fig. 3 and dumped into downslope streams. The aggregate effect of gully erosion contributes a vastly larger amount of sediment to streams in the area. An estimate of the number of erosion gullies or their size is difficult because many of these gullies have

Initially, items such as tires (Fig. 6) and relatively inert chunks of concrete may be placed in these gullies in an attempt to stem the erosion. Eventually, these actions foster further accumulation of other types of trash (Fig. 11), including old appliances (Fig. 3), cars, construction material, dead game animals, discarded cans of petroleum products, pesticides and herbicides. Over time, heavy metals, herbicides and pesticides may leach from the trash and enter and have an adverse effect on domestic, agricultural and public water supplies.

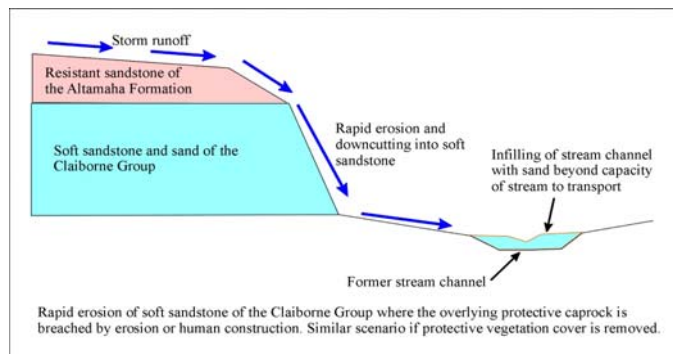
Figure-4 Model of erosion where caprock has been breached

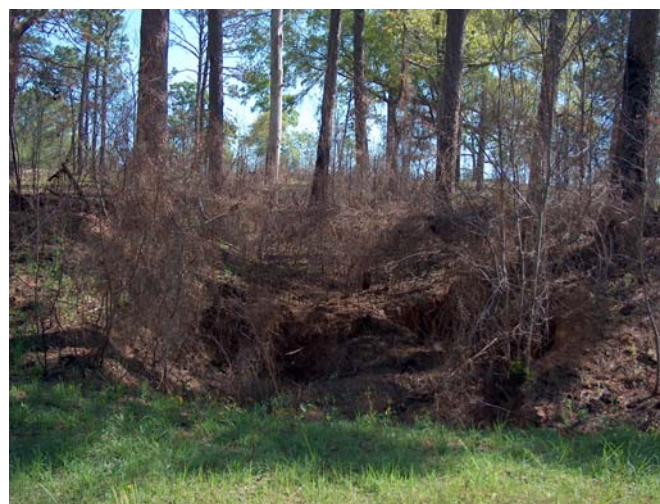
Figure-5 Drainage above culvert pictured in Fig. 6 Entrance to north end of culvert is just above grassy area in this picture.

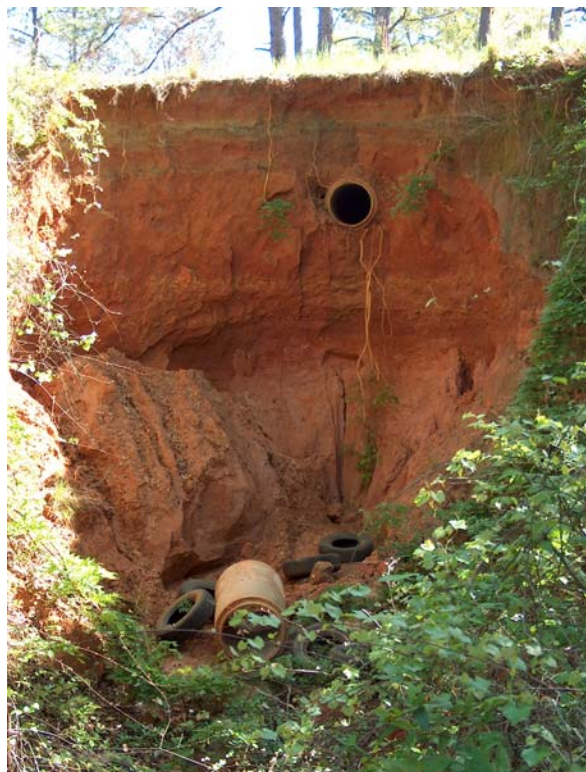
Figure 6. Rapid and significant erosion at south end of culvert across county road in Fig. 5. Note four-foot segment of culvert that has broken off and tires for scale. Another segment lies beneath large block of sediment just behind visible section of culvert.

In places where culverts are sited under roads to channel storm runoff to the downslope side of a road, exceptionally rapid erosion may develop. This type of dramatic erosion poses immediate and longer term hazards to infrastructure and people that depend on them. The immediate threat is a precipitous drop off that may be only a few feet from the road or the road may fail due to abnormal loading, e.g. logging trucks. As shown in Figures 6 and 7, a drop off of about 20 feet is less than 6 feet from the paved road. In one locality, erosion from one year to the next, erosion was so rapid that the sediments supporting an entire section of culvert were removed and the culvert now lies at the base of the gully. The head of that gully now lies about 10 feet from a major highway.

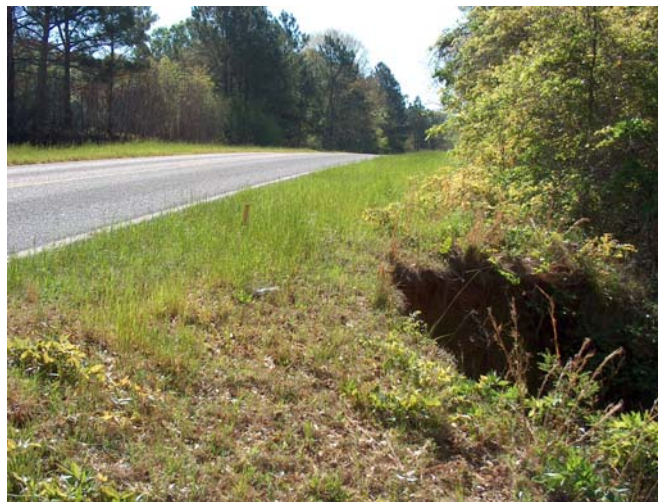
Figure-7 Top of gully shown in Fig. 6 lies within six feet of county road.

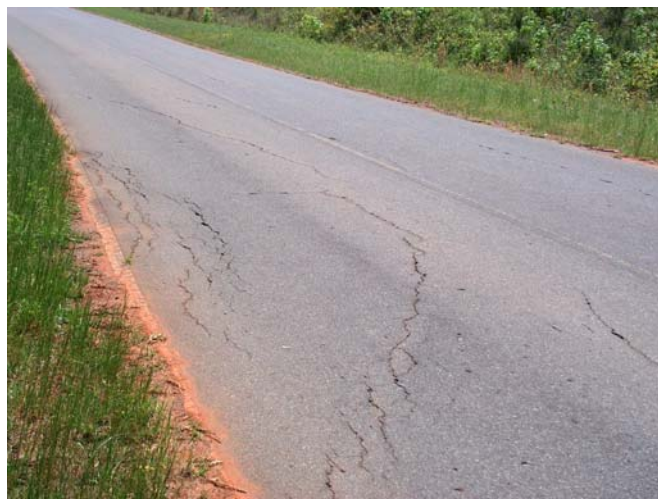
Figure 8. Concentric cracks signifying initial road failure are centered over a culvert at the head of an erosion gully.

A longer term threat is a more gradual weakening of the roadbed and probably eventual collapse. The road in Fig. 8, exhibits cracks that are concentrically arranged over a culvert that heads another erosion gully. Considerable logging has occurred along this road during the past

year, and these cracks are relatively new according to the road supervisor of this county.

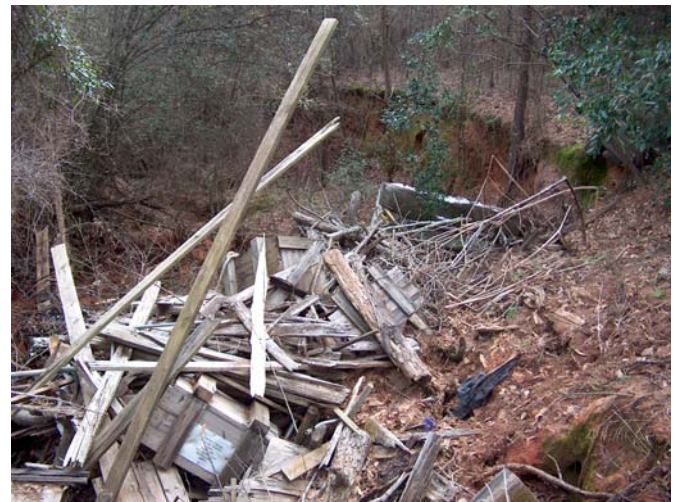
Figure 11. Trash begins to accumulate within these erosion gullies.
