# EFFECT OF FRESHWATER POLLUTION ON THE INTEGRITY OF BRIDGE STRUCTURES IN THE STATE OF GEORGIA

**REFERENCE:** *Proceedings of the 2019 Georgia Water Resources Conference*, held April 15–16, 2019, at the University of Georgia.

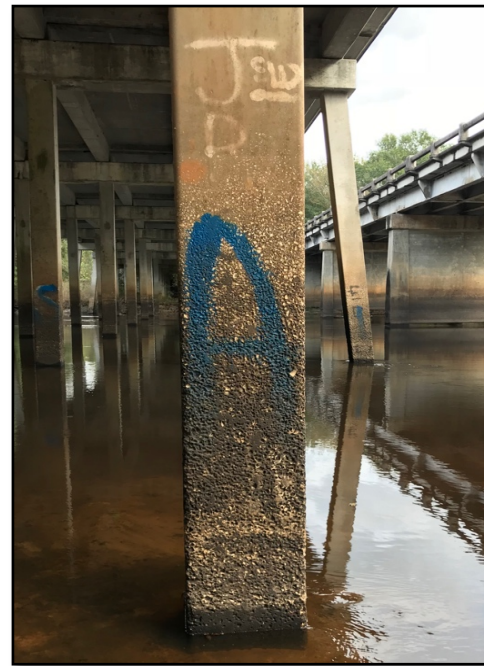
Figure 1: Bridge Site Columns

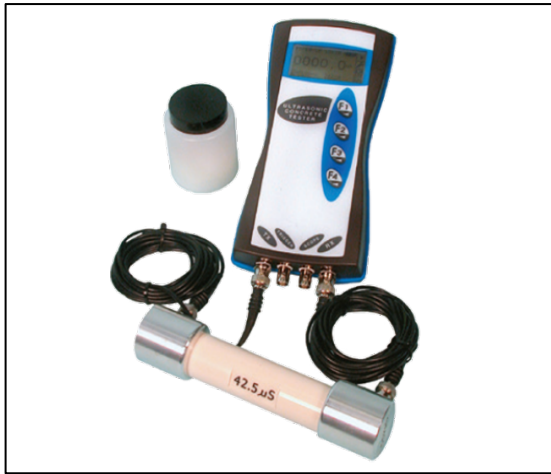
The UPV is a non-destructive test method employed to examine the quality of concrete elements by identifying voids, cracks, honey combs, and compressive strength. The UPV method is described in the American standard, ASTM C597. The device that is used for this method is shown in Figure 2, the Ultrasonic Pulse Velocity Tester (Costel C. et al., 2017). Pulses of Longitudinal stress waves are produced by an electro-acoustical transducer that is in contact with one surface of the concrete. After traversing through the concrete, the pulses are received and converted into electrical energy by a second transducer situated a distance  $L$  from the transmitting transducer. The transit time  $T$  is measured electronically. The pulse velocity  $V$  is calculated by dividing  $L$  by  $T$ .

**Figure 2:** Ultrasonic Pulse Velocity Tester

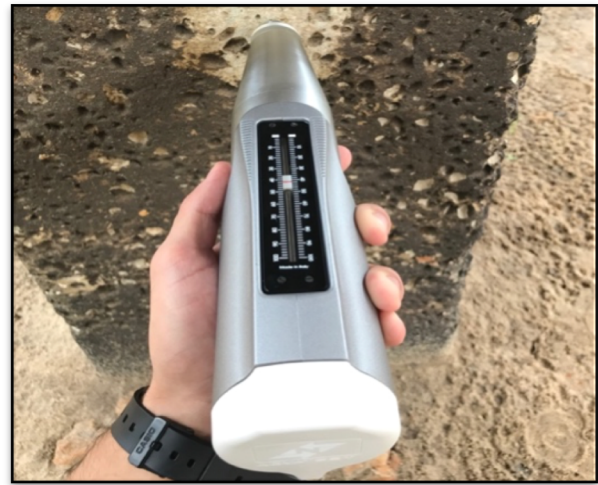
The rebound hammer method is one of the most utilized nondestructive procedures designed for measuring the surface hardness of concrete elements (Costel C. et al., 2017). This testing method is described in the American standard ASTM C805. A steel hammer impacts a metal plunger with a fixed amount of energy against a concrete surface as can be seen in Figure 3.

**Figure 3:** Rebound Hammer

Either the distance that the hammer rebounds is measured or the hammer speed before and after impact are measured. The test result is reported as a dimensionless rebound number. This test method delineates variations in concrete quality to estimate the in-place strength (ASTM C805, 2013).

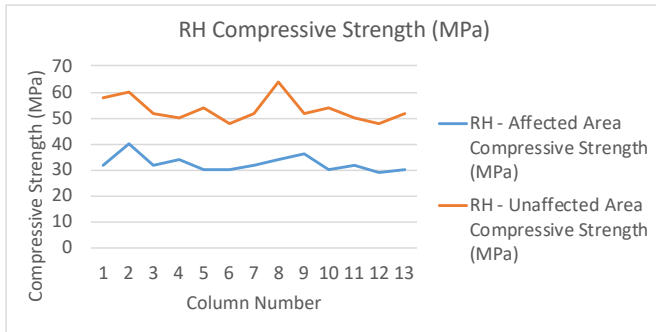
The results from each test method were compared and recorded. Figure 4 is a graphical representation of the different compressive strengths obtained using the RH method of each column. This test method was conducted on the affected and unaffected areas. The average compressive strength for the affected and unaffected areas are 32.4 MPa and 53.4 MPa respectively.

**Figure 4:** Rebound Hammer Compressive Strength

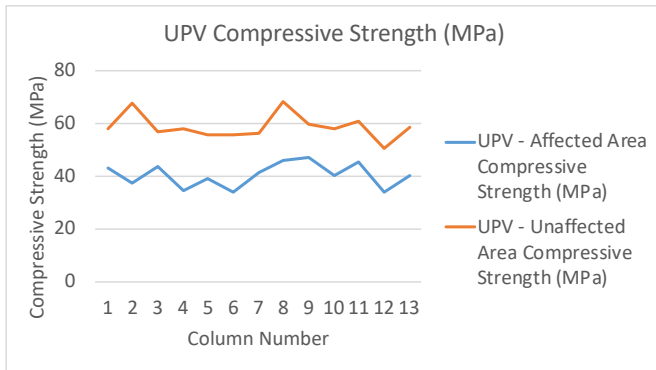
**Figure 5:** UPV Compressive Strength

Figure 5 is a graphical representation of the different compressive strengths obtained using the UPV method of each column. This test method was conducted on the affected and unaffected areas. The average compressive strength for the affected and unaffected areas are 40.4 MPa and 58.7 MPa respectively.
