CREATIVE STRATEGIES FOR IMPLEMENTING PROJECTS TO MANAGE NON-POINT SOURCE POLLUTION: A CASE STUDY FROM THE MCDANIEL FARM PARK STREAM RESTORATION PROJECT

Dale Jones¹, Phil Sacco², Emily Holtzclaw³, and Joel Tillery⁴

REFERENCE: *Proceedings of the 2007 Georgia Water Resources Conference*, held March 27–29, 2007, at the University of Georgia.

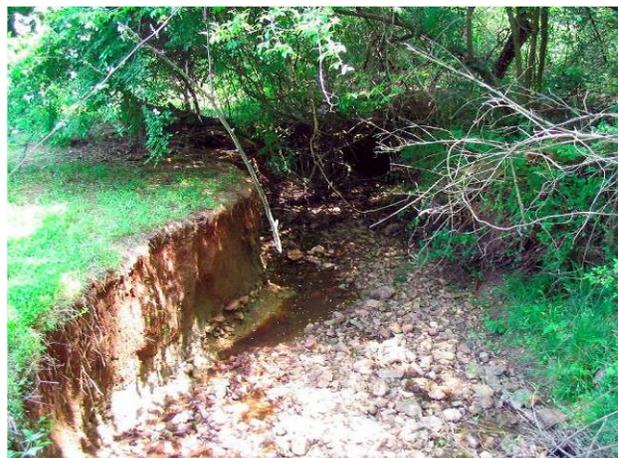
Figure 2. Typical Example of Severely Eroded Bank Conditions

For the next 1,000 to 1,200 feet, the tributary is relatively stable, although there are several places where stream bank erosion is occurring, limiting the overall biotic potential of this site. The third stormwater BMP discharge enters the tributary about 1,300 feet downstream. A 140-foot long open channel, lined with concrete and riprap, connects the outfall structure to the tributary. Riprap was also placed in the tributary to minimize erosion. The last 800 feet of the channel is narrow and deeply incised with bank heights ranging from 4 to 10 feet deep and widths of 5 to 8 feet. The stream banks are eroded and some mass wasting of bank material was observed. Headcuts have formed in this reach and down-cutting is progressing upstream from its confluence with Sweetwater Creek. Figure 2 shows an example of the incised creek.
