A STREAM RESTORATION PLAN FOR THE CITY OF DAVENPORT

E.A. Matthiesen¹, D.F. Spector¹, B. Stineman²

REFERENCE: *Proceedings of the 2011 Georgia Water Resources Conference*, held April 11–13, 2011, at the University of Georgia.

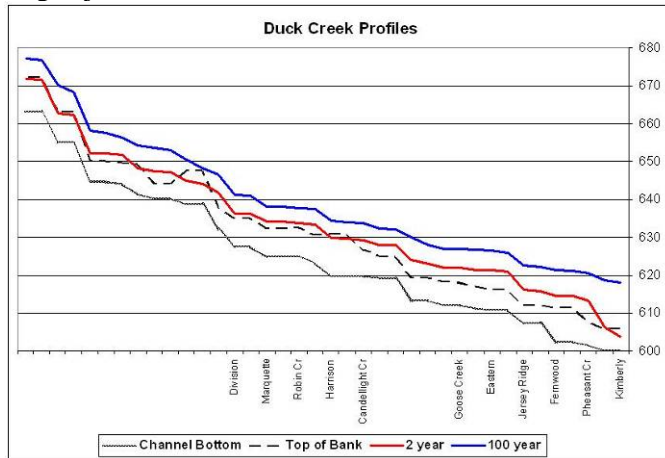
Figure 3. Duck Creek profiles showing channel bottom, top of bank, and 2- and 100-year depths.

Topographic mapping showed the project area to be relatively steep in the upper reaches and then flatter in the Mississippi River floodplain (Figure 3). This shows the necessity of controlling runoff rates and velocities in the undeveloped upper reaches and areas proposed for redevelopment to minimize future erosion impacts to the channel. The agricultural lands in the upstream portion of the watersheds are adequately drained for farming practices. When this land use changes there is the opportunity to add storage and volume management practices that can result in less run-off volume and lower discharge rates. The more downstream reaches tend

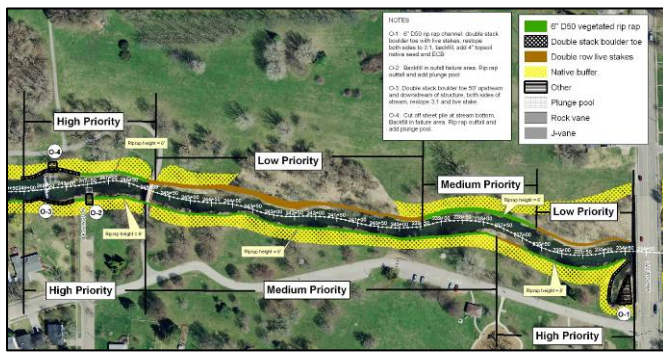
Figure 7. Stream restoration plan for a segment of Duck Creek.

Implementation Plan. For each reach of Duck and Blackhawk Creeks, an implementation plan was developed that details the types of improvements recommended, their priority for implementation, and the estimated cost. The plan also includes maintenance recommendations. Figure 7 shows the implementation plan for about 1,400 linear feet of Duck Creek. Stream reaches were characterized as low, medium and high priority, depending on potential damage to public and private infrastructure and lateral recession rates between 0.1 -0.5 ft/yr – low, 0.06 to 0.2 ft/yr medium, and >0.3 ft/yr as high.
