OCONEE RIVERS STREAM IMPROVEMENT DEMONSTRATION PROJECTS

REFERENCES: *Proceedings of the 2003 Georgia Water Resources Conference*, held April 23-24, 2003, at the University of Georgia. Kathryn J. Hatcher, editor, Institute of Ecology, The University of Georgia, Athens, Georgia.

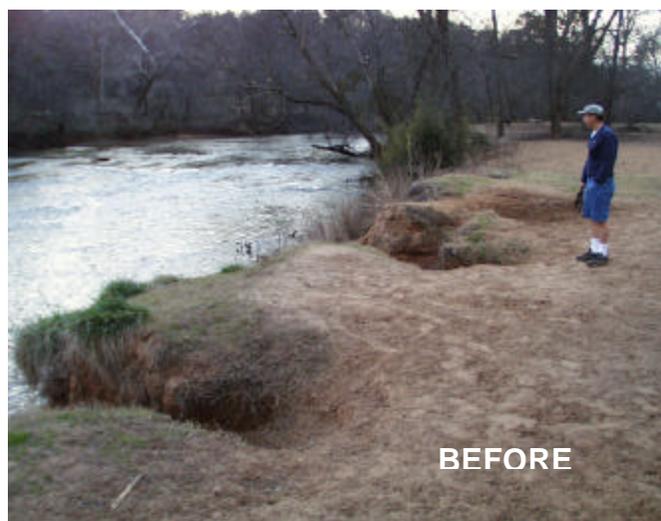
Figure 1. Middle Oconee River at Ben Burton Park, Athens, GA, March 2002.

ment techniques. Plans were developed for the two sites and submitted to the various permitting agencies for approval and to obtain the necessary permits and variances prior to implementation. The first project involved stabilization of a severely eroded reach of streambank on the Middle Oconee River in Ben Burton Park. A 150-foot section of streambank in the park was heavily gullied and unstable due to impacts of regular power line maintenance (elimination of vegetation) and disturbance from people and dog traffic in the park (Figure 1).

The streambank was graded to a stable (3:1) slope configuration. Upon final grade, the slope was stabilized using compost, erosion control matting, and native vegetation. Live stakes were installed at the base of the slope, and containerized native shrubs and herbaceous species were installed further upslope. Grass seed was spread over the project site for temporary stabilization. Steps were built adjacent to the project to direct and concentrate access to the river in this area of the park.

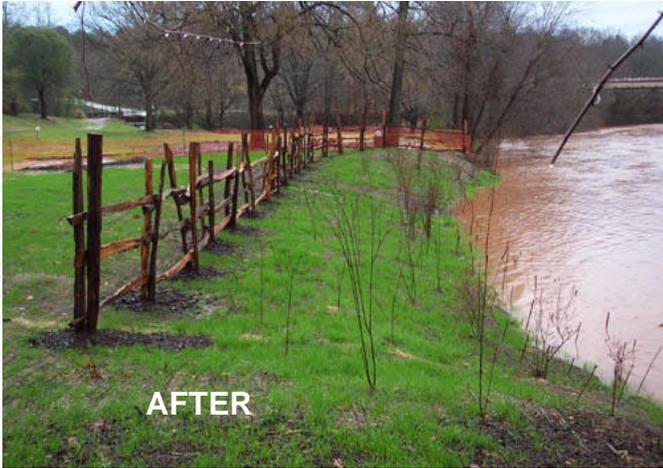
Figure 2. Ben Burton Site. March 2003.

A wooden fence was erected upslope of the project area (Figure 2).

Since the Ben Burton project was installed in late January 2003, several floods have occurred, including an event in early March estimated to be a 10-year flood event. The entire site and park were under several feet of water. The river deposited several feet of sediment on the middle and lower slope area. Although the fence was partially damaged, all erosion control materials and plants remained in place, and stakes and shrubs are sprouting. The Johnson's Meadow site was only recently completed in March 2003.

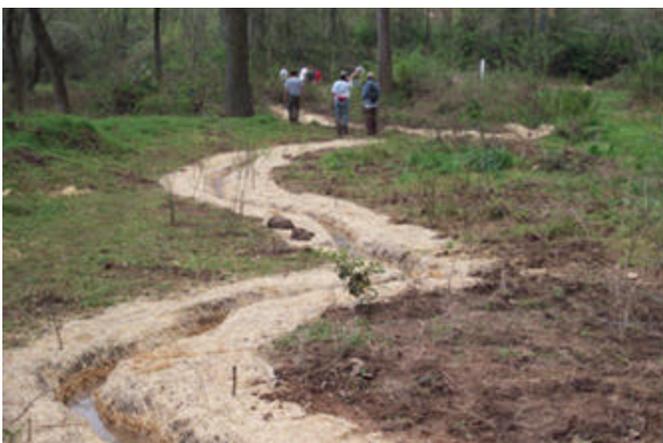
The second project involved restoring a very small, unnamed perennial stream that flows through an area of the North Oconee Greenway known as "Johnson's Meadow." The stream was historically channelized and closely paralleled a sewer line whose right-of-way is regularly cleared of vegetation. Project activities included

- Exotic species (privet and kudzu) control,
- Re-routing the stream away from the sewer line in a newly-created meandering channel pattern through the adjacent floodplain area, and
- Stabilizing and re-vegetating the channel area with native vegetation (Figure 3).

Figure 3. Johnson's Meadow along the North Oconee River Greenway, March 2003.
